## **DESTRUCTIVE EVALUATION AND EXTENDED FATIGUE TESTING OF RETIRED AIRCRAFT FUSELAGE STRUCTURE: PROJECT UPDATE**

**John G. Bakuckas, Jr.**  
**Materials and Structures Branch, AAR-450**  
**FAA William J. Hughes Technical Center**  
**Atlantic City International Airport, NJ 08405, USA**

### **Abstract**

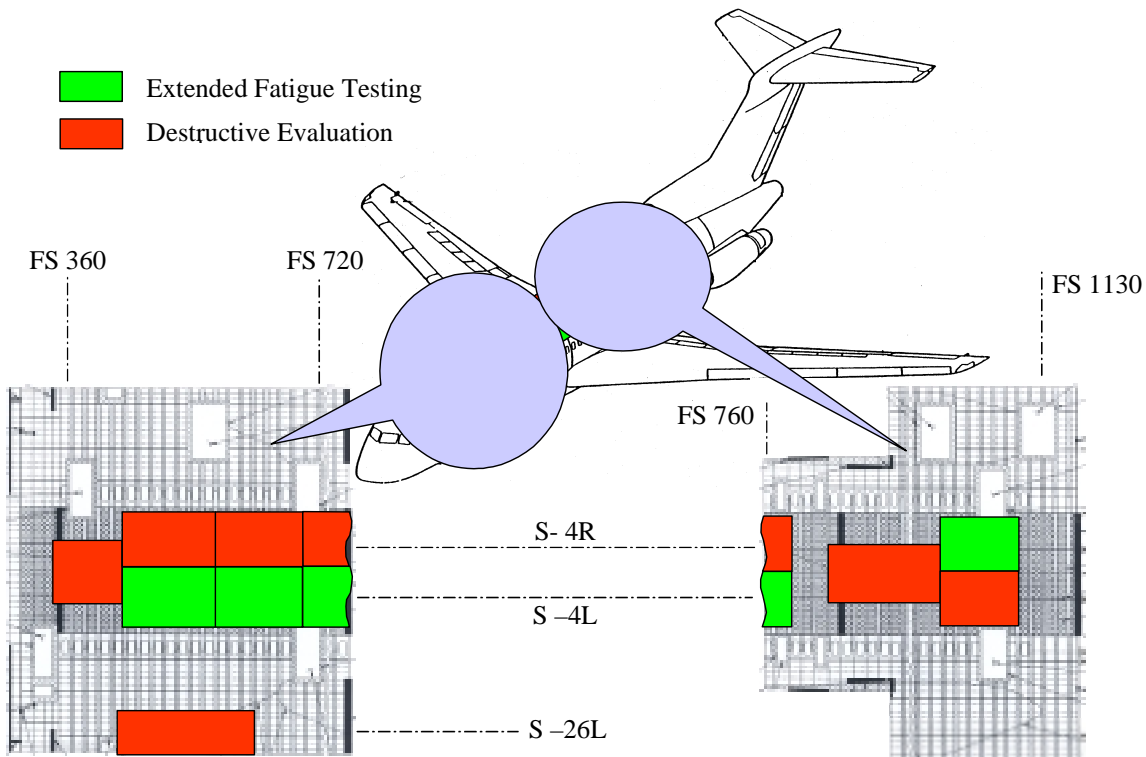
Figure 4. Target structure for test and analysis

Nine fuselage lap joint areas susceptible to WFD, each approximately 8 by 12 ft, were removed from the aircraft, five will be destructively evaluated and four will be subjected to extended fatigue testing, Figure 4. Prior to removal, all target sections were labeled with boundaries and identification marks to indicate the location and orientation of the section with respect to the aircraft. In addition,

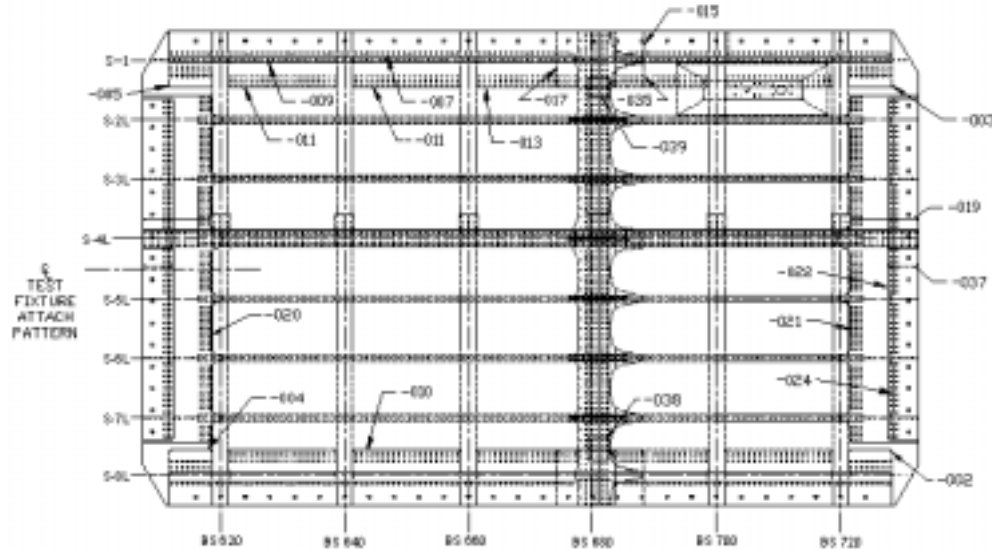
Figure 6. FT2 test panel

A preliminary test plan was developed for the first fuselage panel to be tested, FT2, shown in Figure 6. The panel consists of six frames, FS- 620 through 720, and six stringers, S-2L through 7L, and contains a longitudinal lap joint along S-4L and a butt joint along FS-680. Reinforcing doublers were installed at the load applications points along the perimeter of the panel and at the ends of the frames.

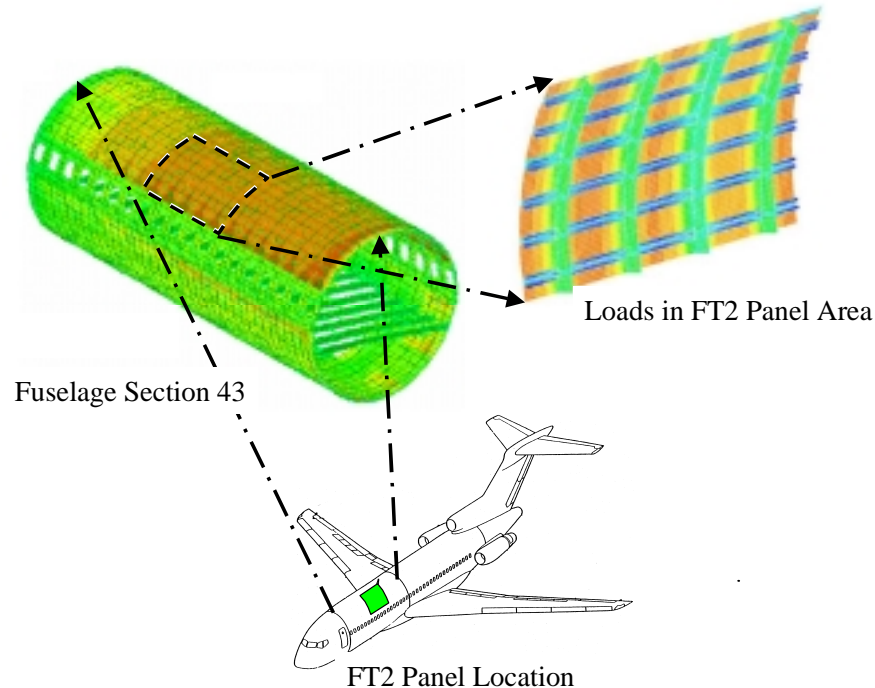
Figure 7. Finite element analysis to determine loads applied to FT2 panel

Geometrically nonlinear finite element analysis was undertaken to assess stresses in the B727-200 fuselage subjected to pressure and flight loads and to estimate the FASTER loads for the FT2 test panel. The loads included internal pressure applied to the skin, axial loads due to the pressure and bending, and shear loads due to the weight of the aircraft, passengers, and cargo. Shear was found to be negligible in the area of FT2. Preliminary results are shown in Figure 7.

The fuselage skin stress is due primarily to cabin pressurization and fuselage bending. The cabin pressure differential ( $\Delta P$ ) varies little from flight to flight and was found to be 8.6 psi based on usage history of the aircraft. On the other hand, fuselage bending is a function of maneuver, gust, and other varying loads whose frequency of occurrence is typically unknown. A preliminary load spectrum was developed based on the truncated version of the Transport Wing Structures (TWIST). The mini-TWIST is an overly aggressive spectrum for the B727 in which limit load would be unrealistically exceeded several times in single flight. Instead, it is suggested that 50% of the mini-TWIST spectrum amplitude be used, which agrees well with exceedance data measured on B737 aircraft having similar mission profile to the target aircraft in this study.
